Docket No. 217 – Development and Management Plan Inspection

Northeast Utilities Service Company Certificate of Environmental Compatibility and Public Need for the construction of a 345-kV electric transmission line and reconstruction of an existing 115-kV electric transmission line between Connecticut Light and Power Company's Plumtree Substation in Bethel, through the towns of Redding, Weston, and Wilton, and to the Norwalk Substation in Norwalk, Connecticut.

Date: December 30, 2004

Location: Norwalk Substation Expansion

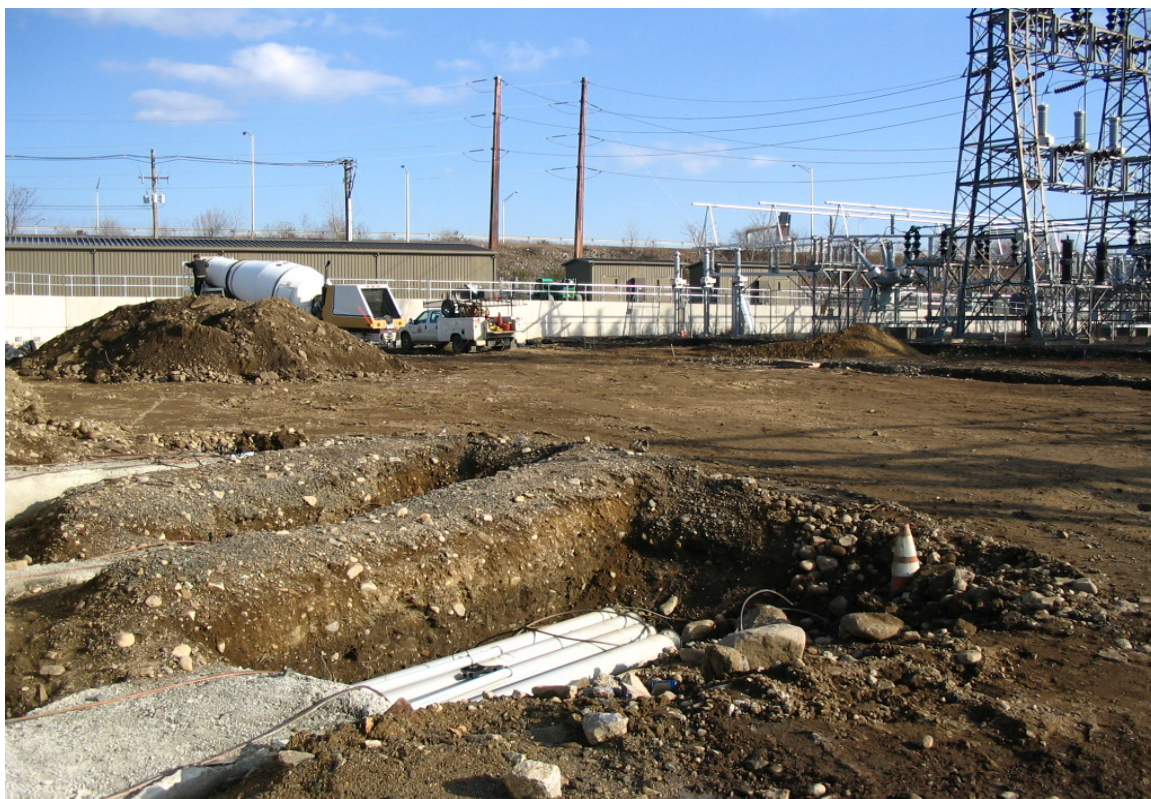
View of new minor excavation to the south of wall #3. Some stockpiles resulted but all soil is contained within the site. 12/30/04

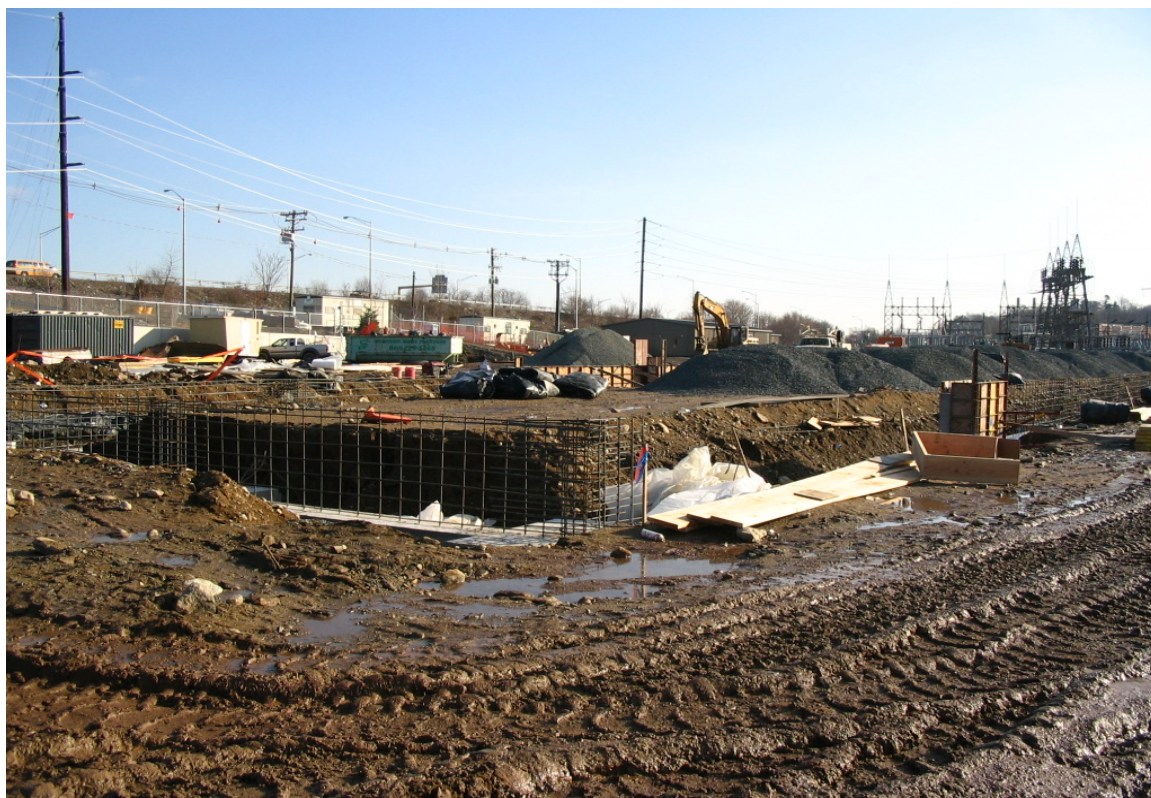
View of the forms and footings being constructed for the GIS building. 12/30/04

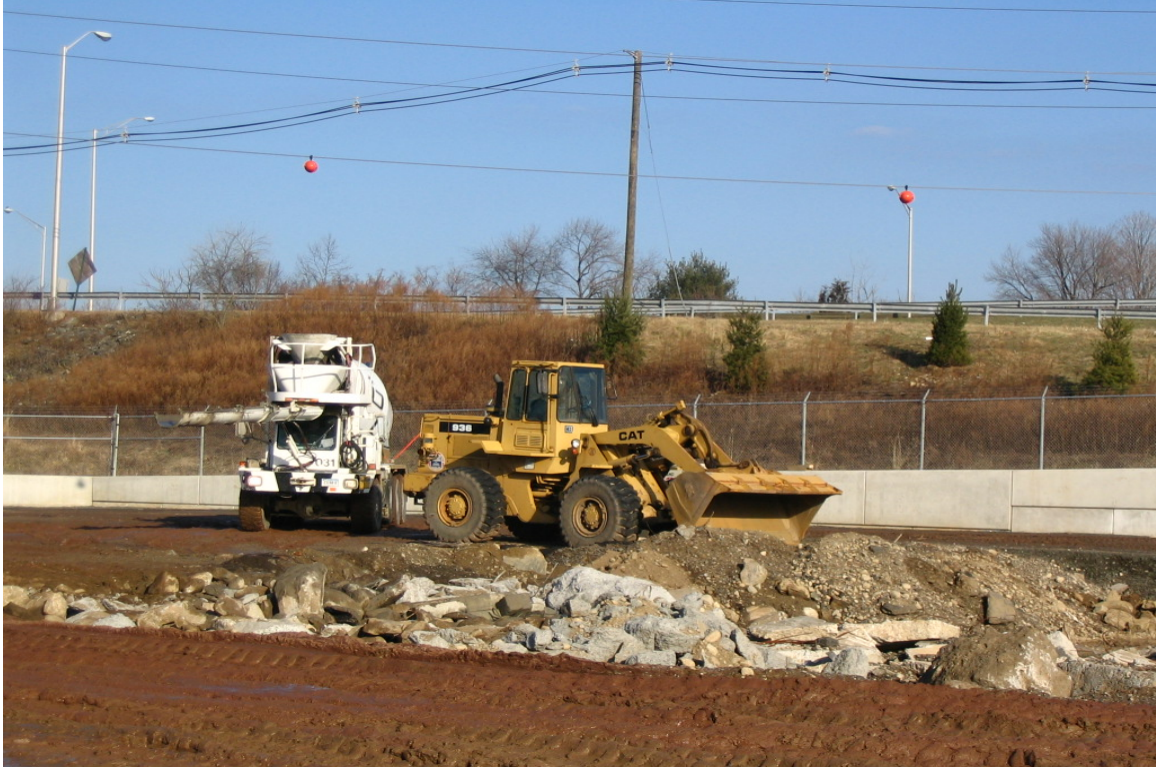
- Concrete washouts have resumed in the contained pit in the center of the site as appropriate, but concrete truck and wheel washing was noted in the yard. 12/30/04	-Any activity creating concrete wash water should be restricted to the pit as well. 12/30/04

Concrete washouts have resumed in the pit in the center of site as appropriate but All concrete truck and wheel washings should take place here as well. 12/30/04

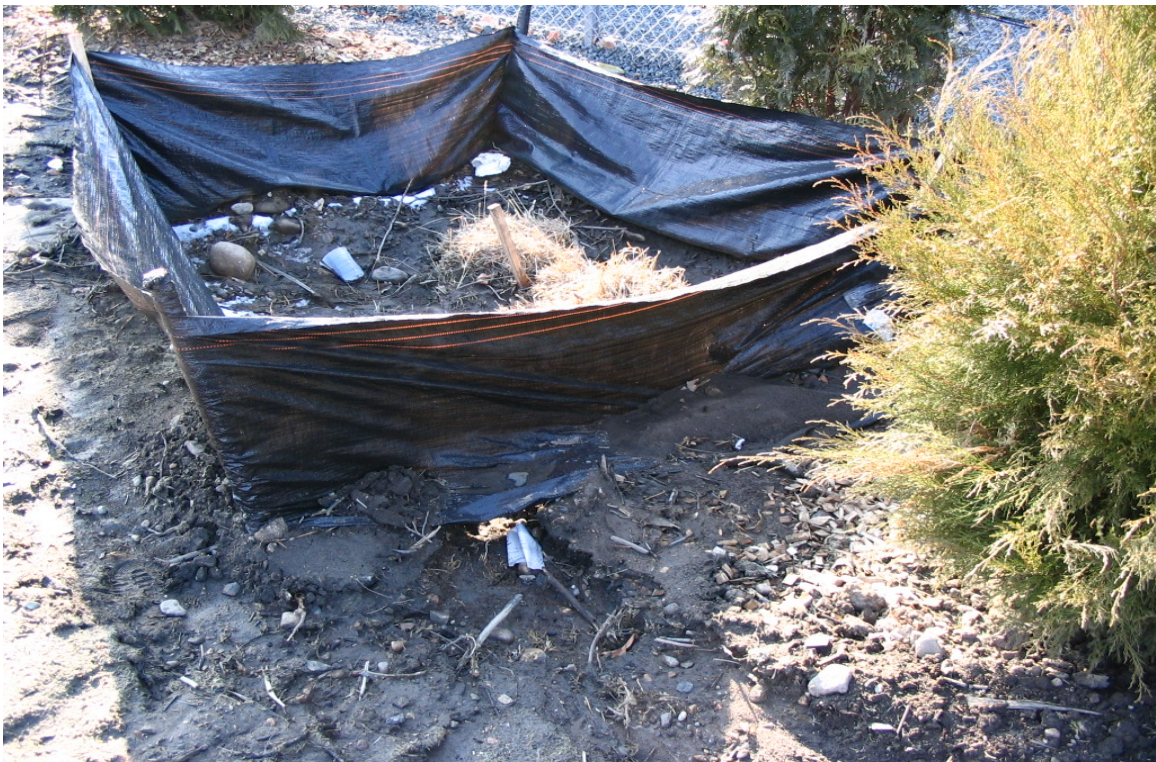
- A haybale has been placed at the flared inlet near the Rt 7 ramp, but the silt fence was undermined by runoff . 12/16-12/22/04	- Continue to monitor for effectiveness. 12/30/04 - The silt fence should be toed in 6" and the sediment cleared from around the inlet. 12/30/04

A haybale was placed at the inlet near the Rt. 7 ramp but rainfall has eroded under the sit fence placed around it. The fence should be toed in 4-6" inches and sedimentation cleared away. 12/30/04

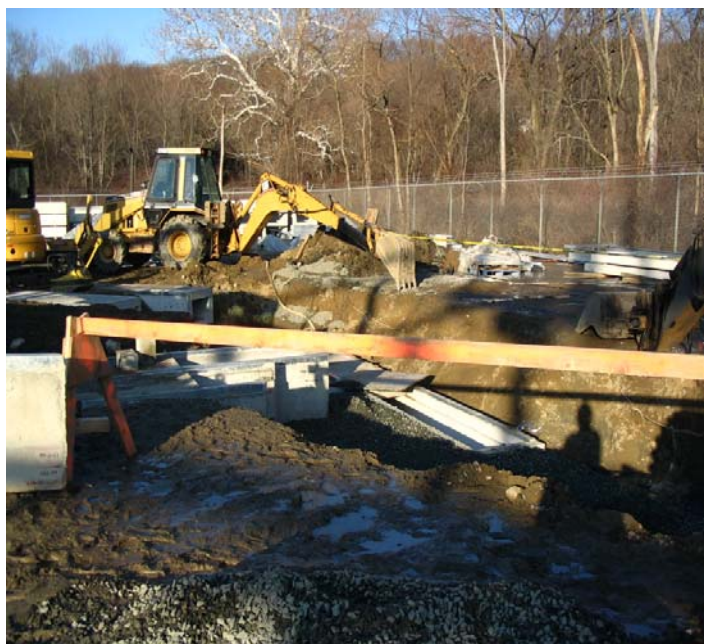
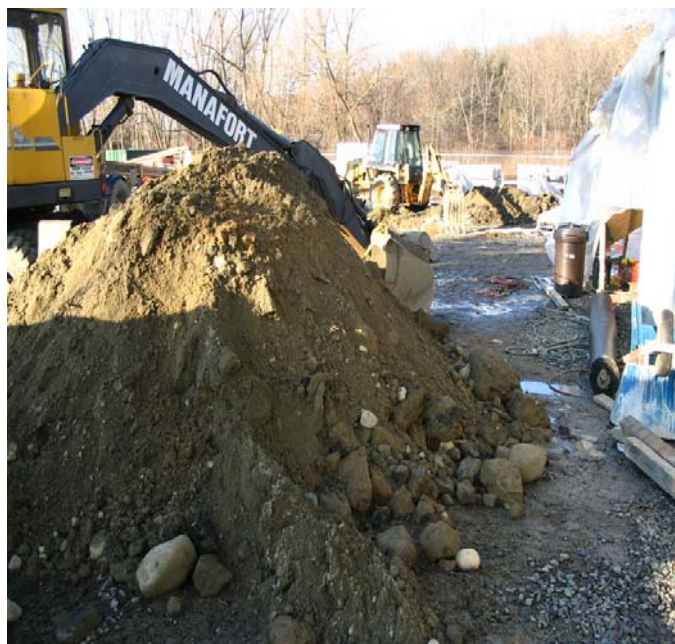
Plumtree Substation: View of the excavation on the new trench closer to the perimeter fence. The stockpile is contained within the site. 12/30/04

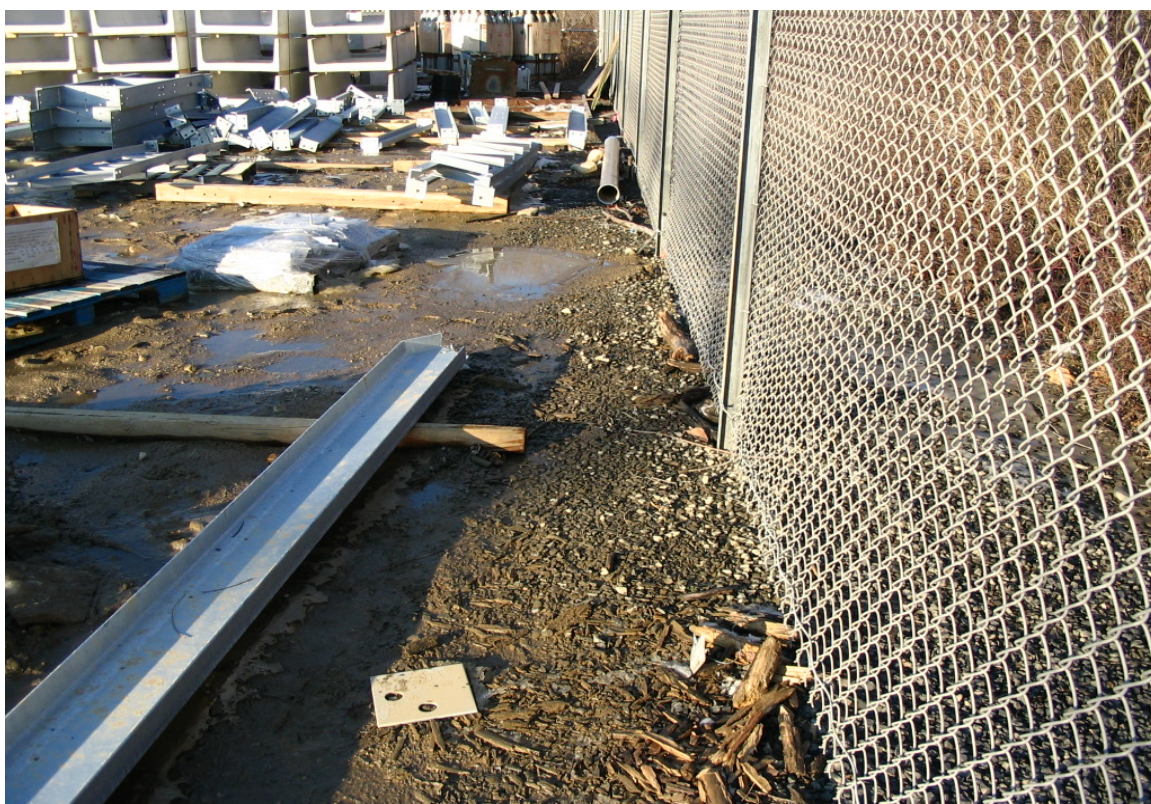
- The stone perimeter berm is well in place and contains the yard. It effectively prevents any turbid water from leaving the site. The low spot could be reinforced. 12/30/04	- The berm is working well at this time. Consider reinforcing the berm in low spots as activities approach. 12/30/04
Inland Wetland and Watercourse encroachment and mitigation	- Wetlands are located around the outskirts of the substation yard. Work is fairly close to the perimeter fence but there is no noted sedimentation to the wetland area. 9/10-12/30/04	- The stone berm around the perimeter of the yard continues to prevent sedimentation and water from leaving the site and getting to the wetland edge. 9/23-12/30/04
State species of concern, threatened and endangered species	- No species of concern are located in this area of construction.	- N/A
Vegetative clearing limits (including trees to save or danger trees noted)	- No vegetation outside of the substation yard will need to be cleared during the expansion work.	- N/A

Although the gradient of the yard slopes away from the fence overall, small isolated areas have the potential to spill over towards the wetlands. The berm is low here and should be reinforced. 12/30/04
